MPERG Report 2006-2

Pilot Scale Erosion Control Using Bioengineering Techniques at Gold Run Creek, 2005

Laberge Environmental Services

February 2006

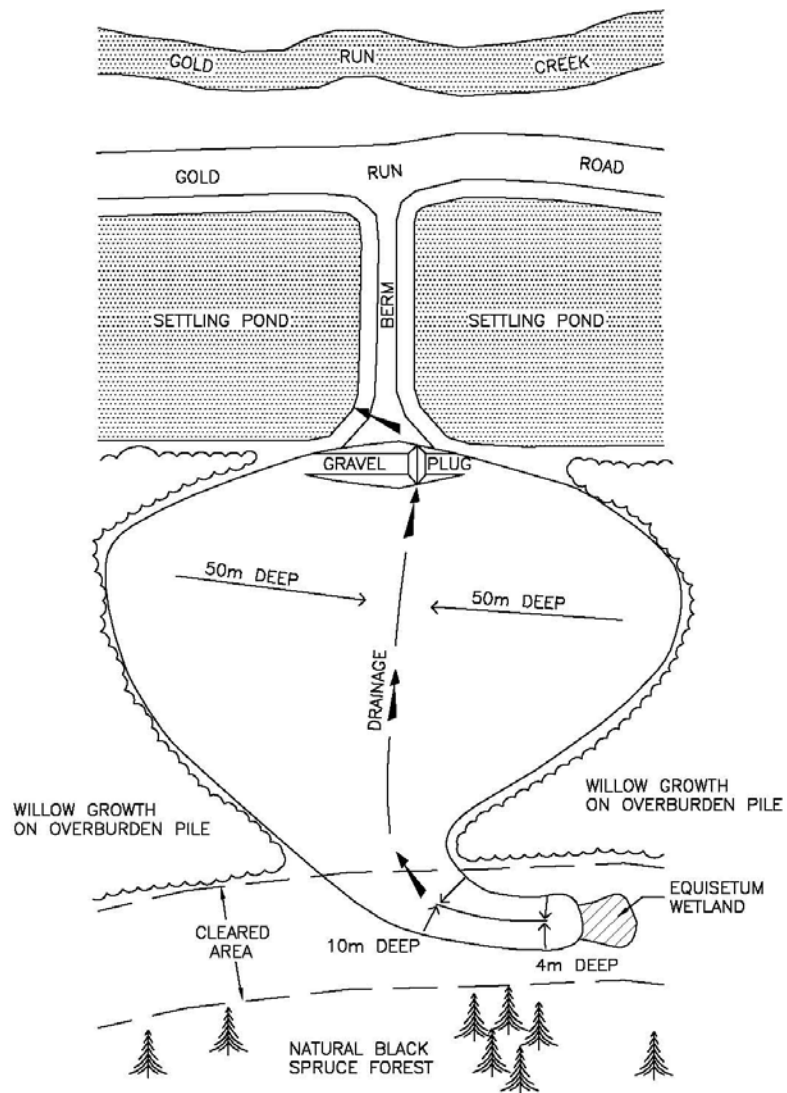
Figure 1 – Slope Failure Near Gold Run Creek
(Not To Scale)

It is unclear just when the slope failure first occurred. By July 2003, soil had slumped back to a point about 300 metres from the creek bank (see Figure 1). The width of the slumped-in area ranged from about 4 metres at its apex to about 60 metres at its centre. The maximum depth was estimated to be about 50 metres. The walls of the gully were nearly vertical in places.

Vertical cracks in the soil about one metre deep had formed up to 20 metres back from the sidewalls at various locations, indicating the instability of the thawed overburden. The depth to frost in mid-July ranged from 20 cm near the apex of the slope failure to about one metre at the top of the overburden stockpile. Water was discharging from the base of the erosion cut at a rate of about 0.1 litres / second.

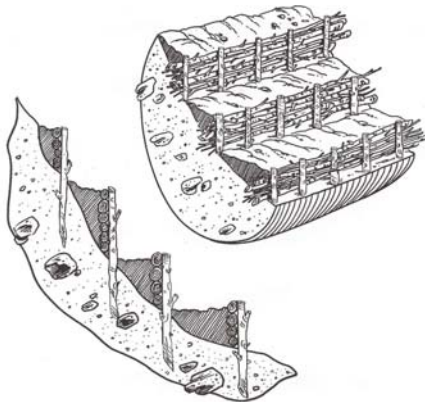
Wattle fences (D. Polster)

Starting on the flattened gully floor, a series of three 'steps' was installed up each gully wall. Larger diameter willows (10 to 13 cm) were pounded vertically into floor of the gully. Long cuttings of numerous smaller diameter (2 to 7 cm) willows were laid horizontally against the vertical posts. Earth from the gully wall was backfilled to the willows. Once the height of the horizontal willows reached approximately 30 cm, horizontal posts were inserted perpendicular into the face of the gully. These were tied to the vertical posts and provided added stability. Several additional willows were laid against the vertical posts on top of the horizontal posts, and backfilled. This constructed 'step' then provided the work space for construction of the next wattle fence/reinforced earth wall.

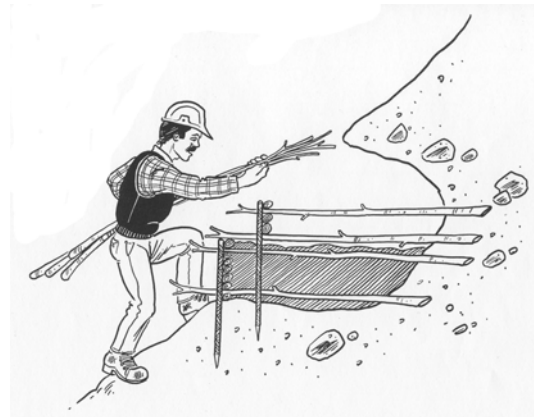
Live reinforced earth walls (D. Polster)

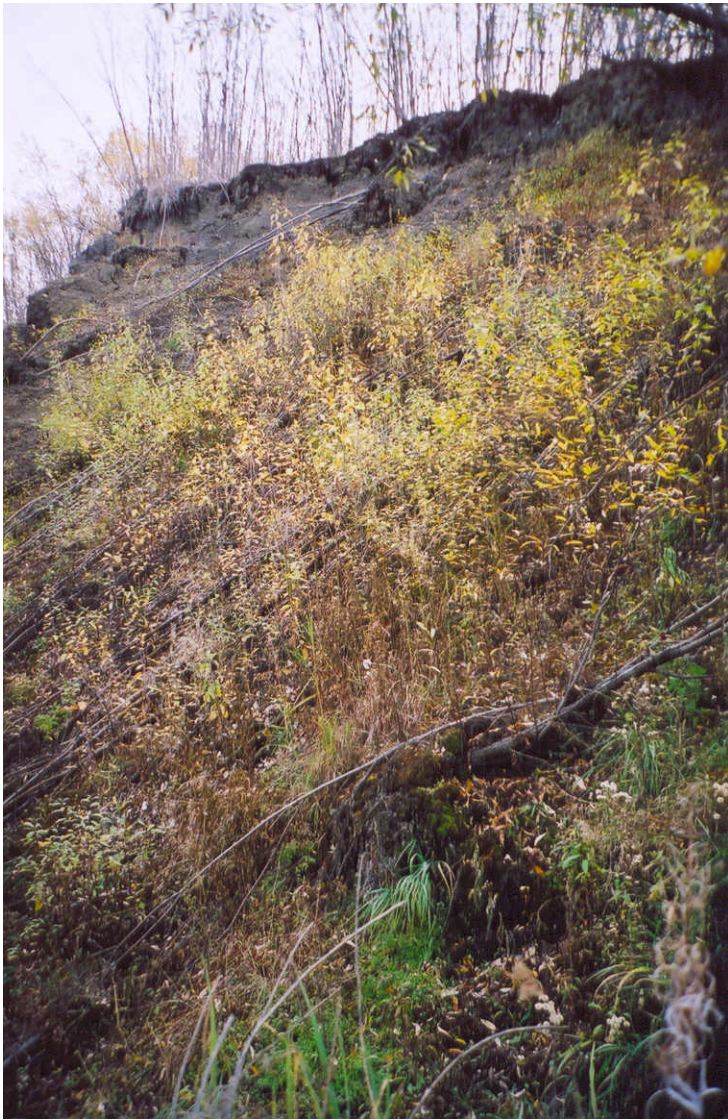
Willow shoots growing from slumped willows on north west facing wall. September 9, 2005.

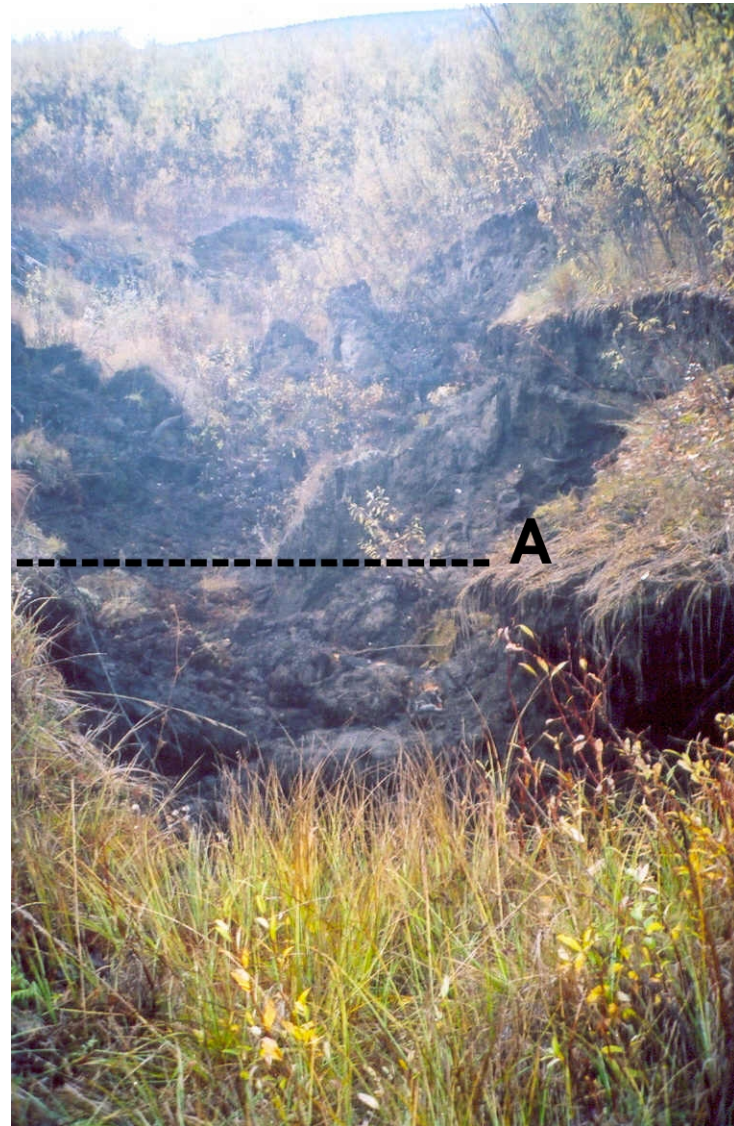
The cut had eroded approximately seven additional metres into the bench since the earlier visit in May 2005. The summer season in the Dawson area had been very wet (personal communication, L. Millar) and the resulting increase in flow had contributed to the expansion in erosion. In addition, a hole approximately 10 metres deep had been created at the apex of the cut during this short time period. The water flowing into the cut was estimated at three to four litres per second. In comparison, the estimated rate of flow during the reconnaissance trip in July 2003 was only 0.1 litres per second.

The cut has receded back from "A" since May 24th, 2005. Photo taken on September 6th, 2005.

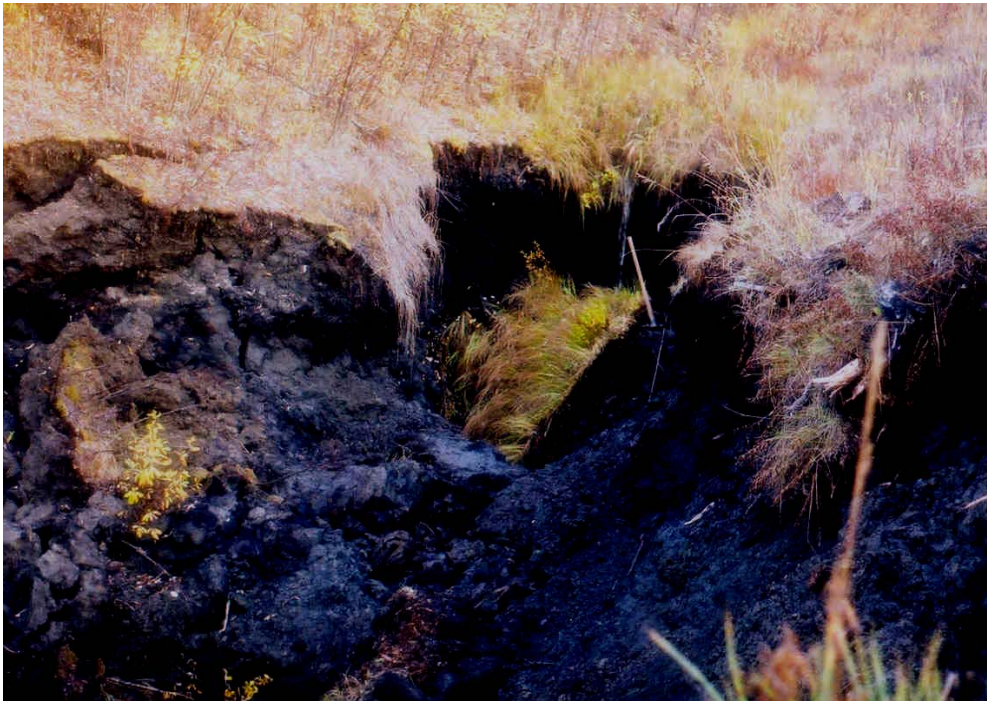
Top of cut prior to any restoration work, September 6th, 2006

Prior to the construction of any restoration work, the steep walls of the upper section of the cut had to be recontoured. Due to limited access to the site, and the fact that any further disturbance is undesirable, this was accomplished with hand tools. The recently created deep hole and eroded tunneling had to be backfilled prior to work on the rear wall. Large woody debris lying near the site, as well as all trimmings from the willows, were placed into these undermined areas. Existing slumping soils were also added as fill.

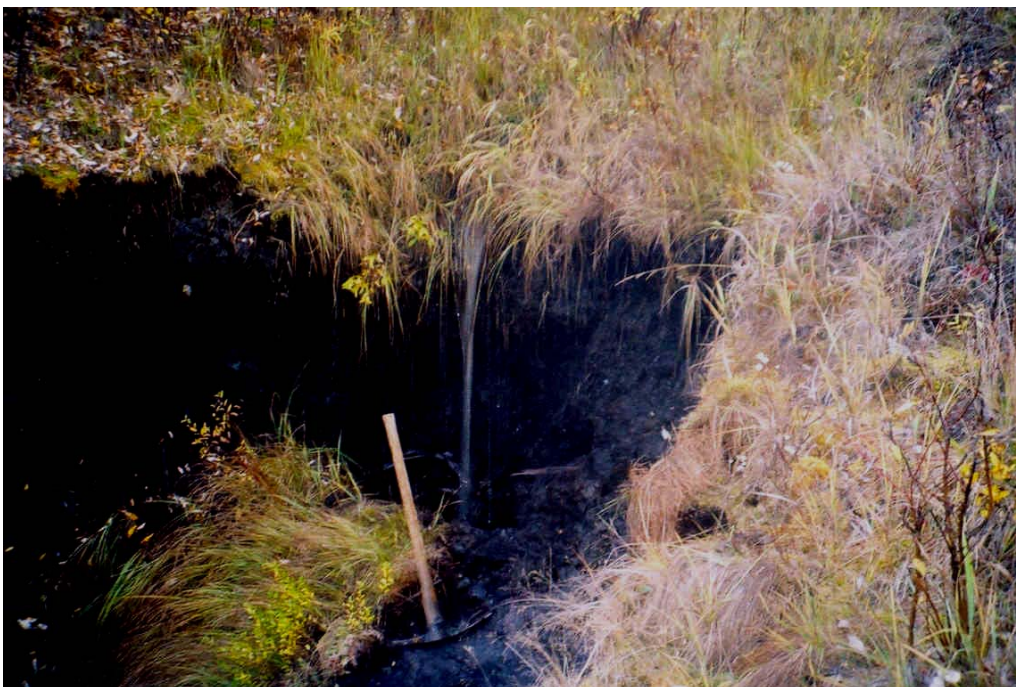
Top of cut prior to any construction, flow estimated at 3 to 4 litres/second, Sept 6th, 2006

Prior to work on the rear wall, the flow had to be diverted. Rigid rubber hose, diameter four inches, was donated by a local placer miner, Norm Ross. A small earth dam was fabricated upstream of the cut, the pipe inserted and laid along the lowest bench of the

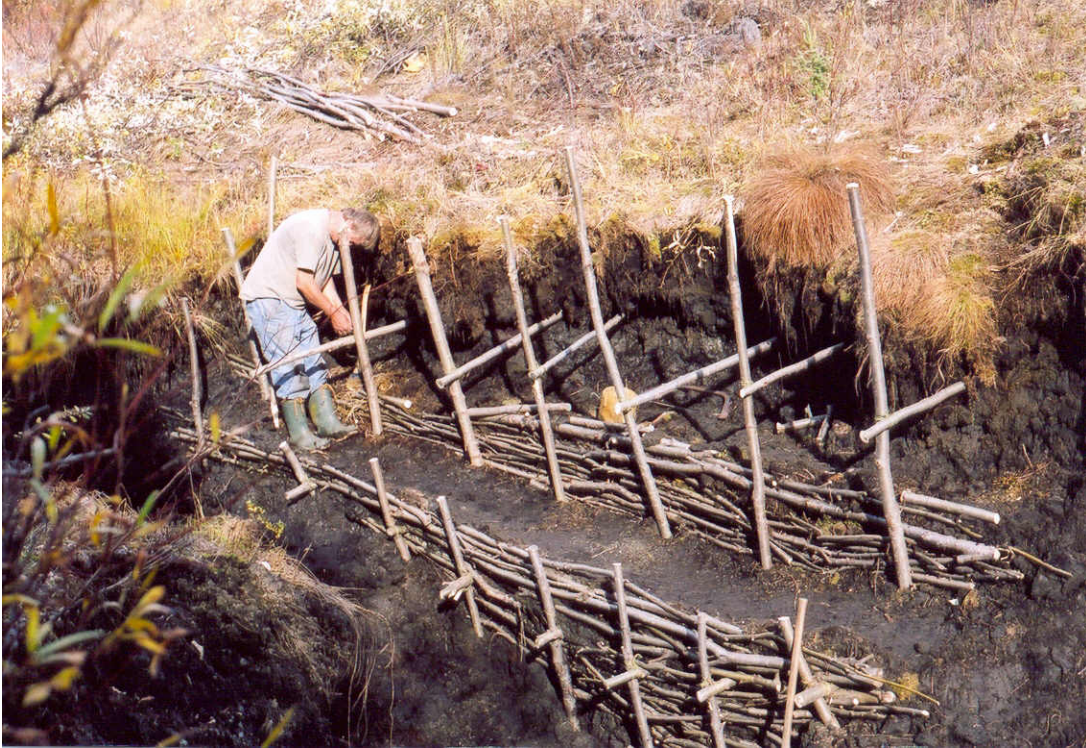
Constructing second tier on the east wall. September 6th, 2005.

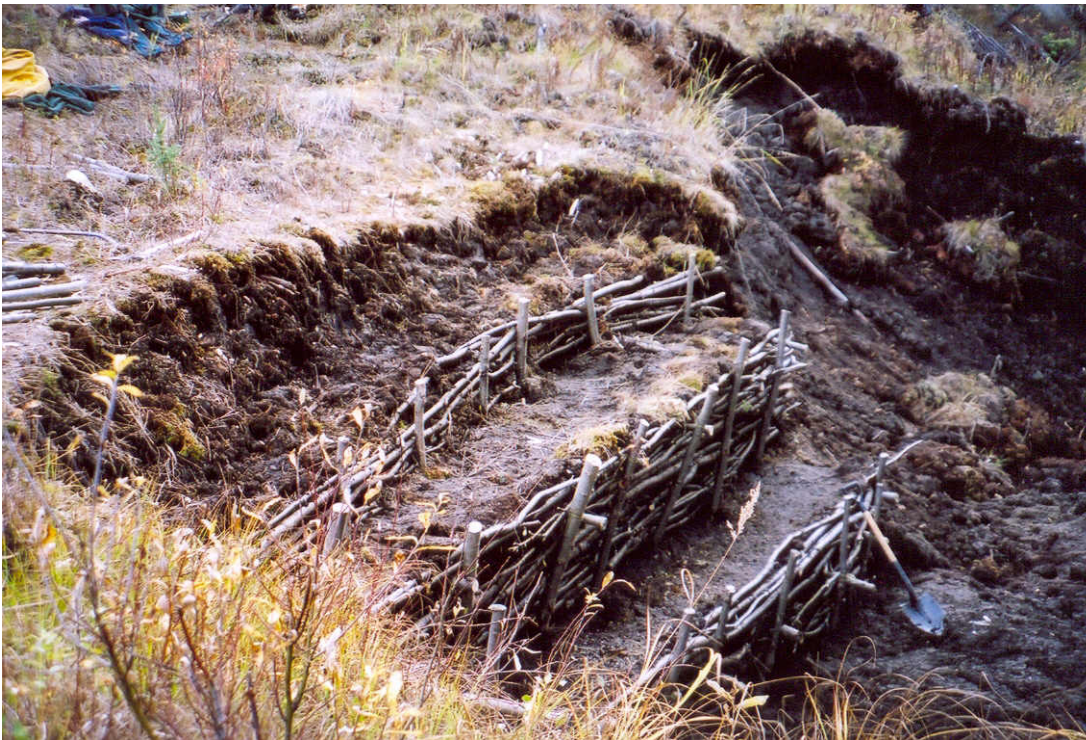
East wall completed, looking down the cut. September 7th, 2005.

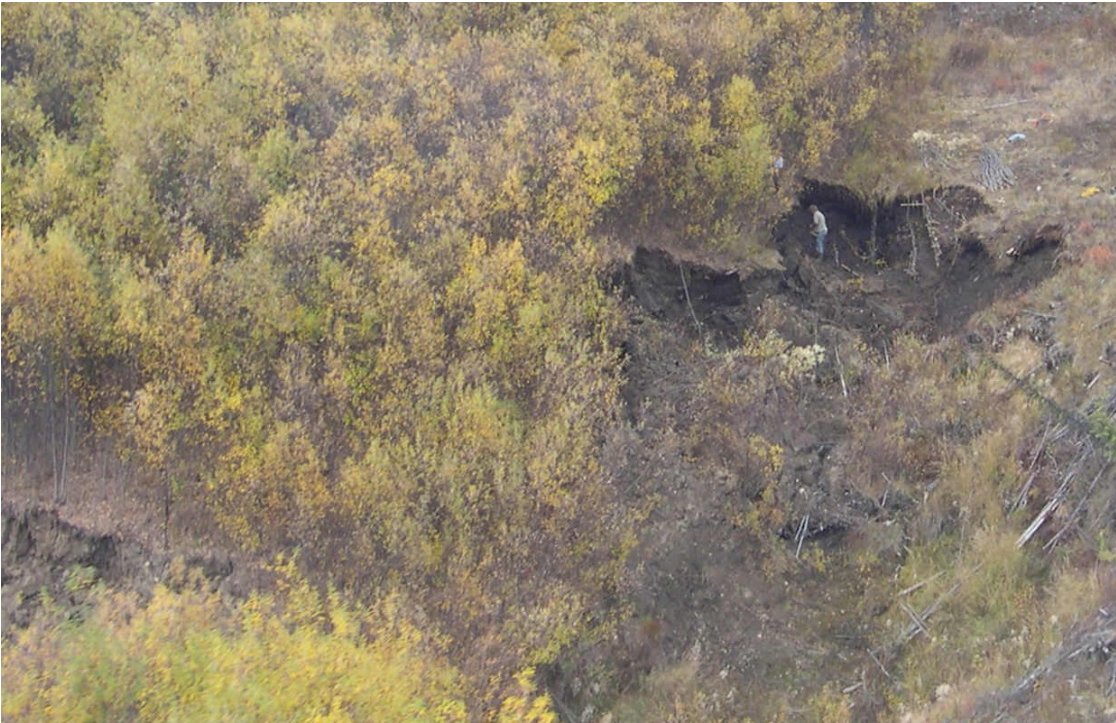
Aerial view of the upper portion of the cut. The completed structures on the east wall can be seen in the upper right. Stabilized section in the foreground. September 7, 2005.

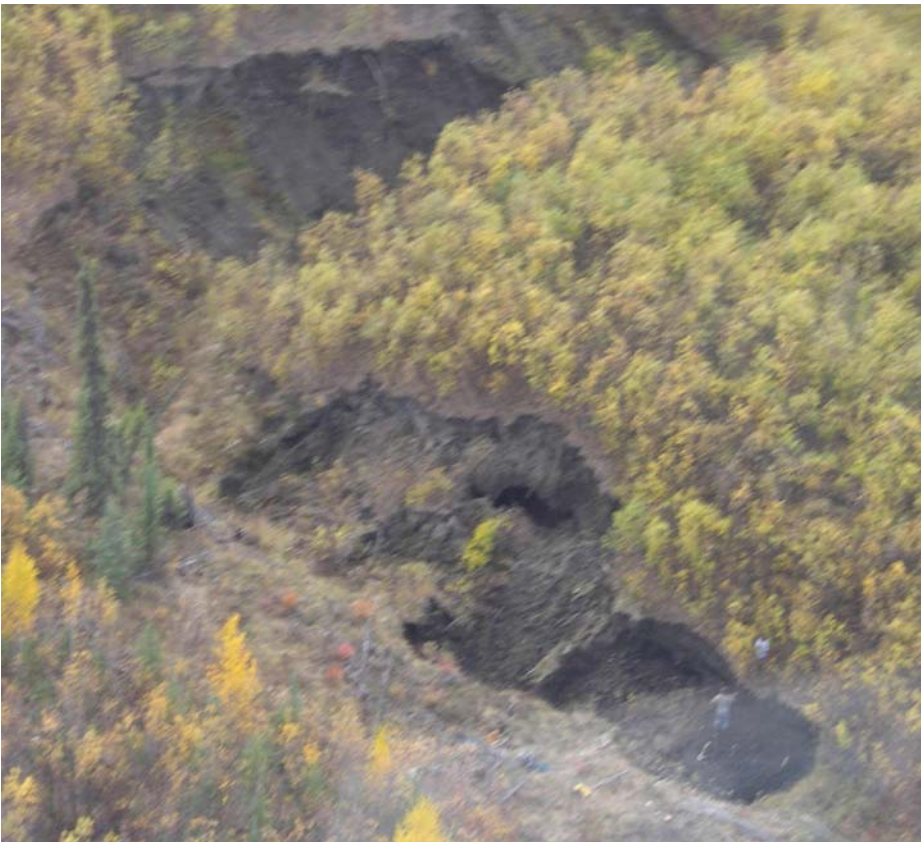
Aerial view looking back along the cut. Work is commencing on the west wall. Sept. 7/05

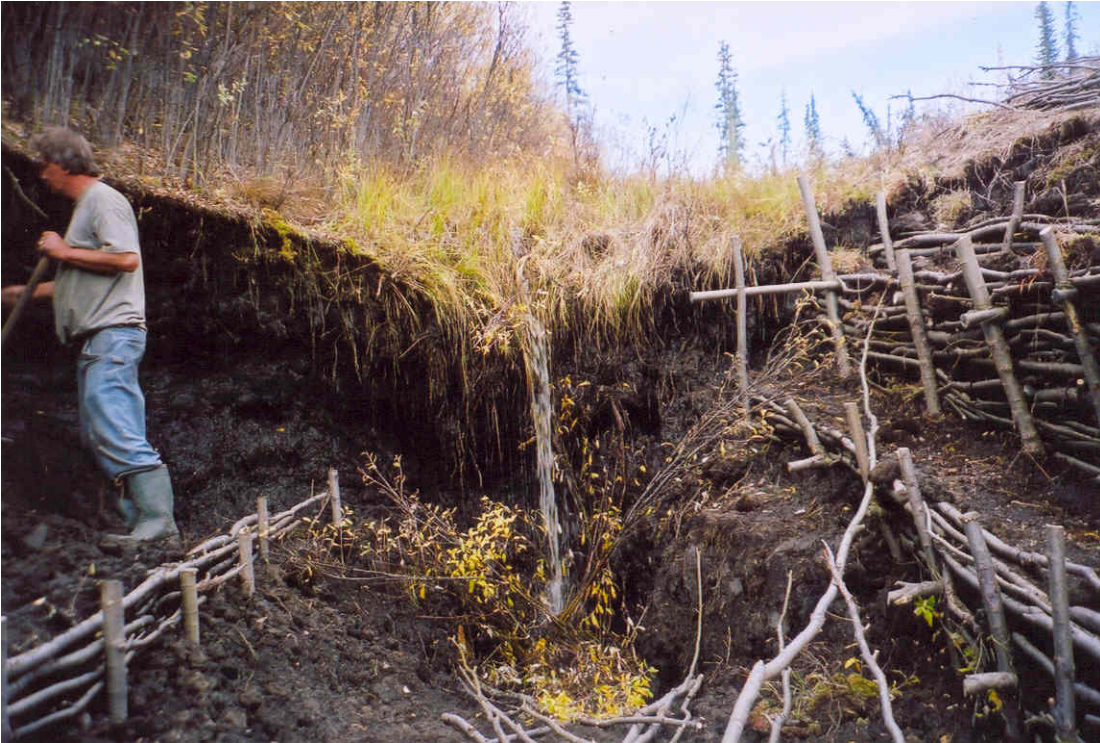
West wall construction, September 7th, 2005.

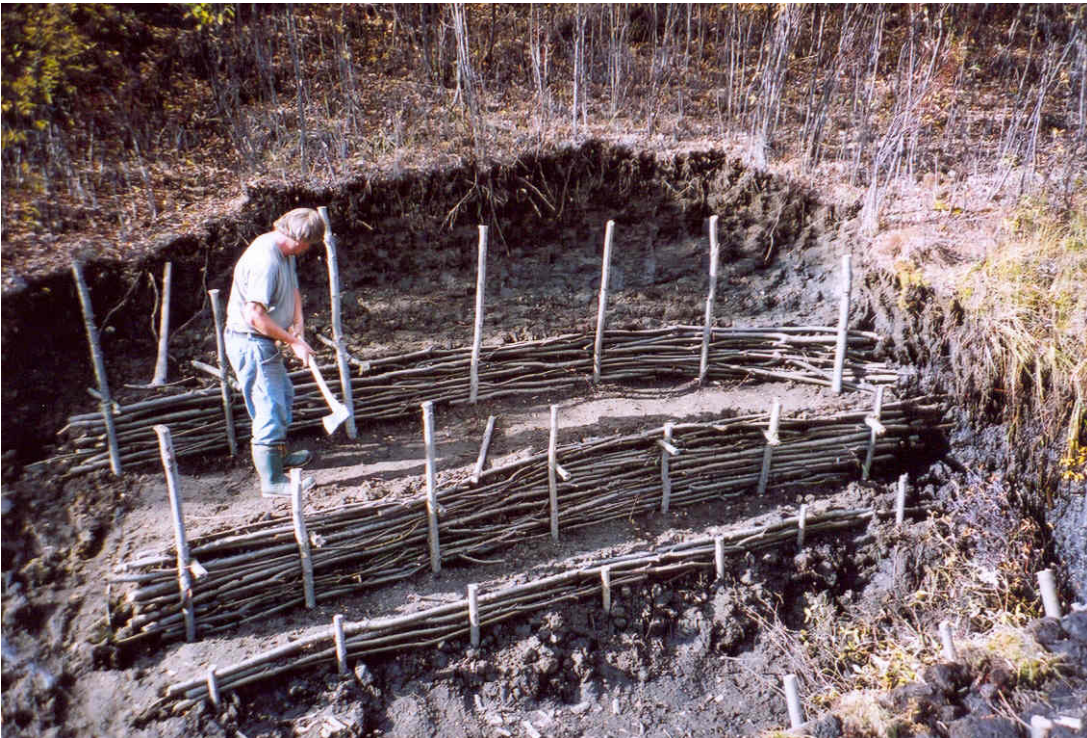
Working on final tier on the west wall, September 8th, 2005.

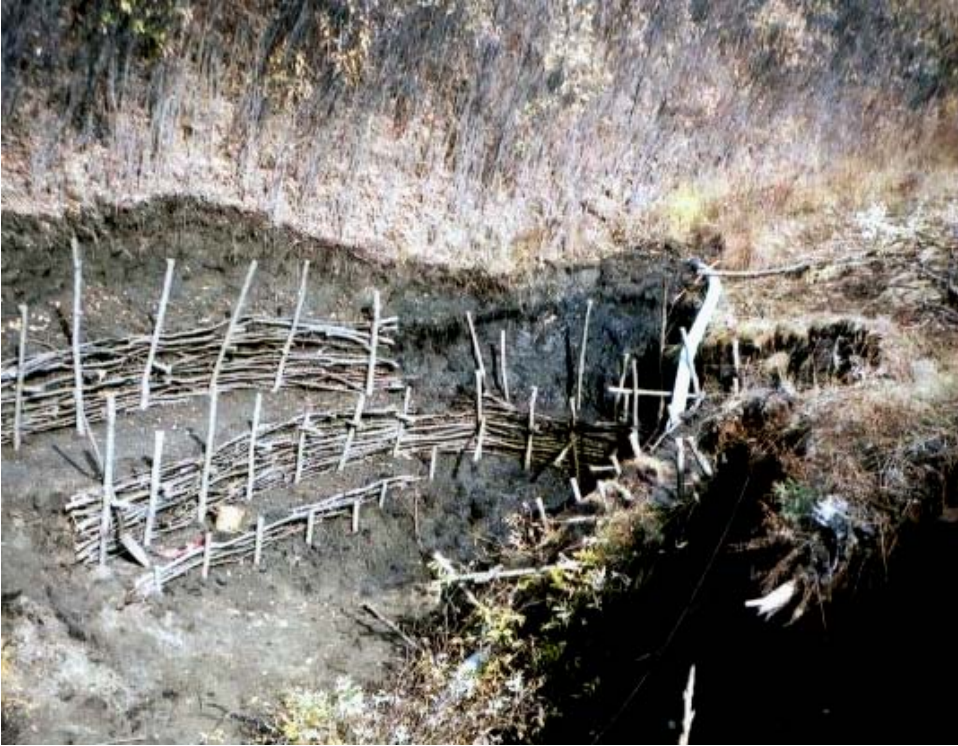
First retaining wattle fence completed on rear wall, September 9th, 2005.

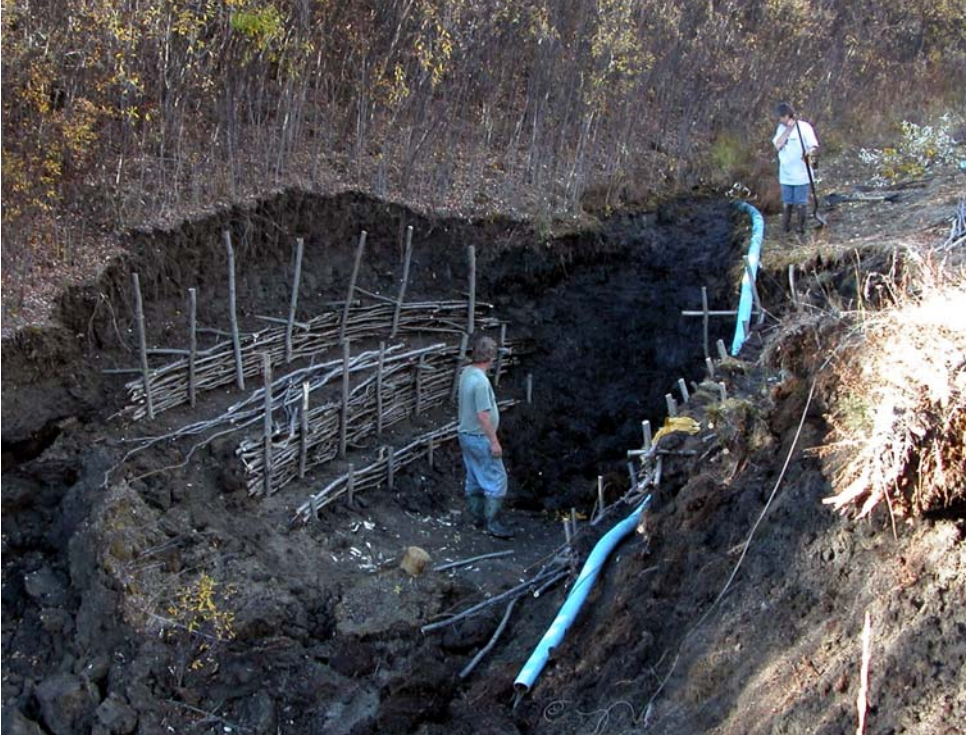
The two tiers of retaining walls have been backfilled in readiness for the installation of the live willow flume. September 9th, 2005.

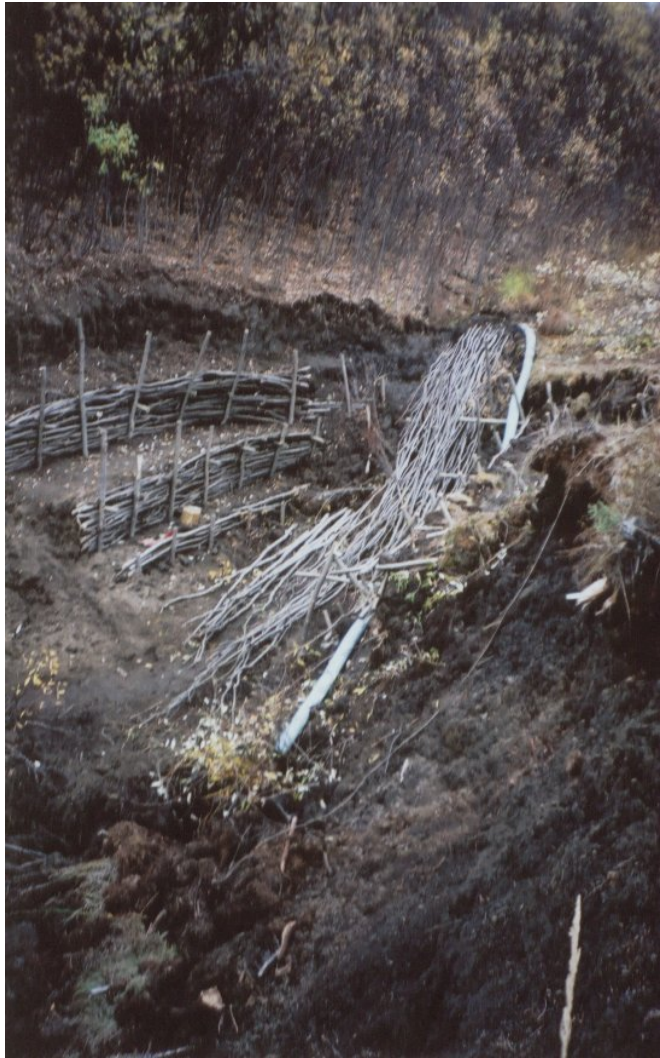
Live willow flume prior to the placement of cross willows. pipes installed. September 9th, 2005.

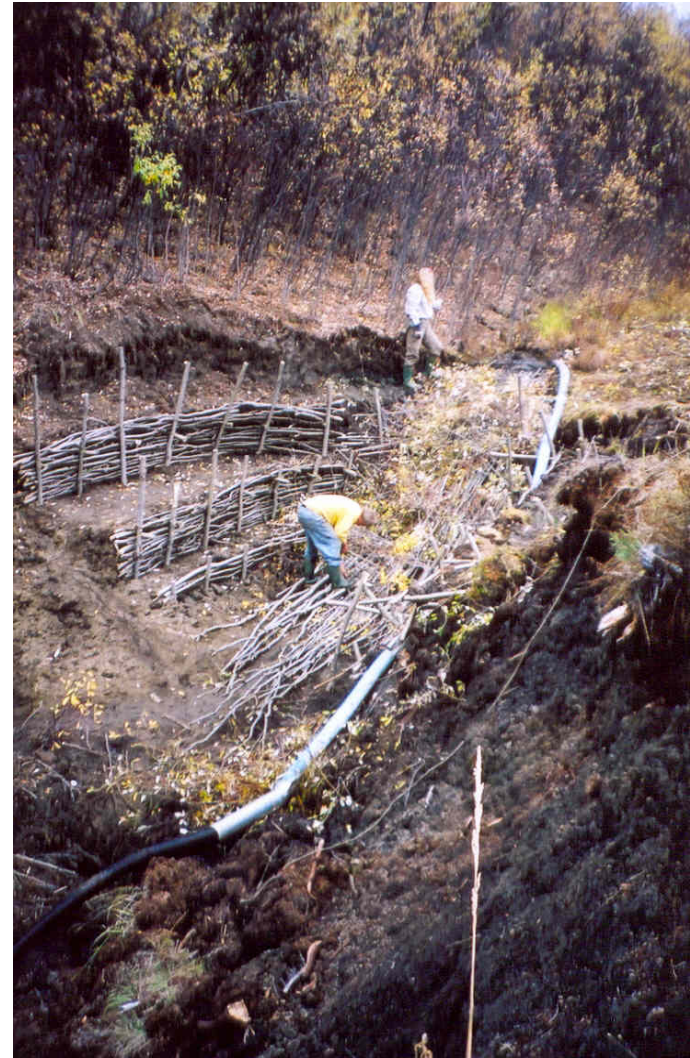
Completed live willow flume and retaining walls, with both September 9th, 2005.
